TEST REPORT

Sample Name : Deflector ASM-FRT S/D Wat& Deflector ASM-FRT S/D Wat

Part No. : 52021971/52021972/94768342/94768343/26353842/26353843/26397838/26397839/26397840/26397841/52183543/52183544/52183545/52183546/52183547/52183548

Test Summary :

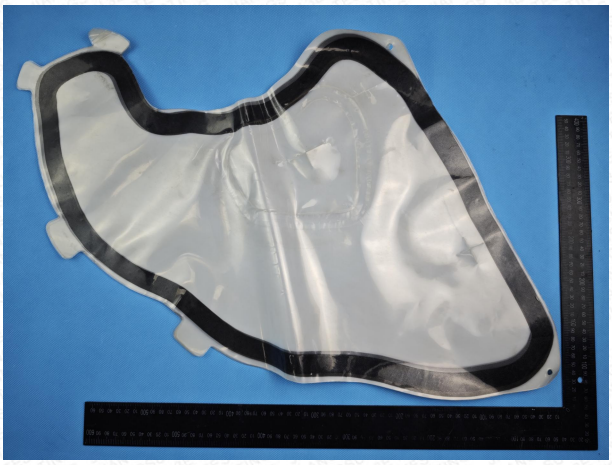
Fig.1-1 Sample photo

No.	Test result	Technical requirements	Test conclusion
1	Leakage after 67 minutes	It does not leak for more than 24 hours	Fail
2	Leakage after 72 minutes

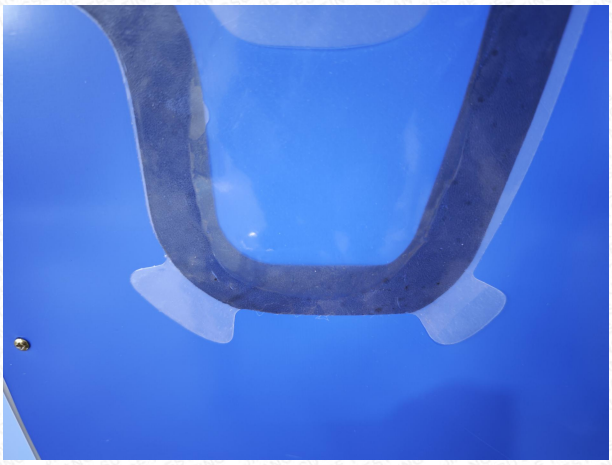
Fig.1-2 Water leak test photo

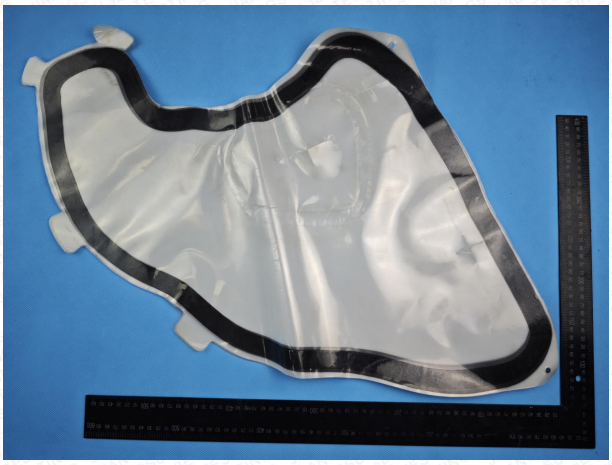
Fig.2-1 Sample photo

No.	Adhesion N /m	
	（23℃ 5min）	(23℃ 15min)
1	73.2	78.4
2	73.6	79.3
3	73.3	78.7
Technical requirements	＞150	＞200
Test conclusion	Fail	Fail

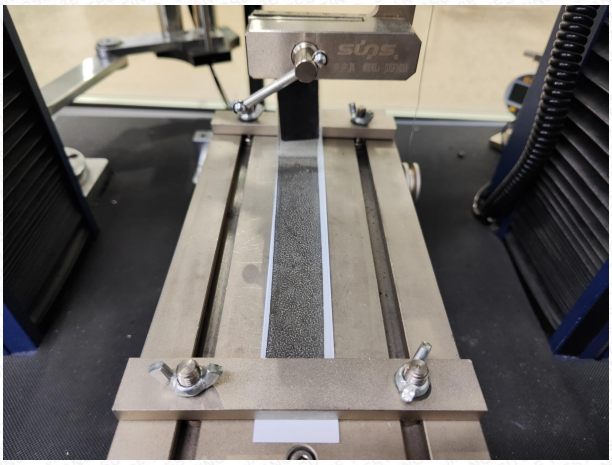
Fig.2-2 Adhesion test photo

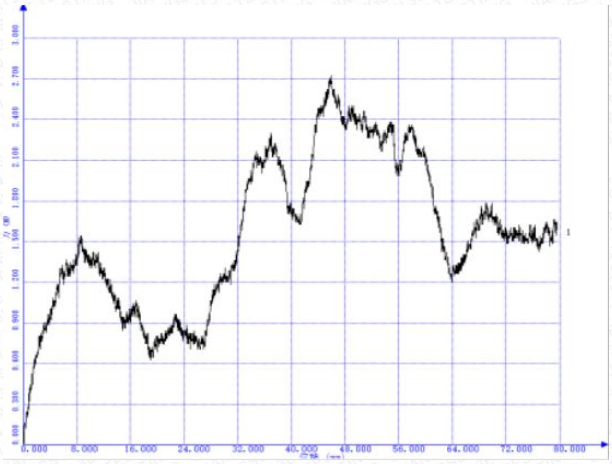
Fig.2-3 Test curve(23℃ 5min)

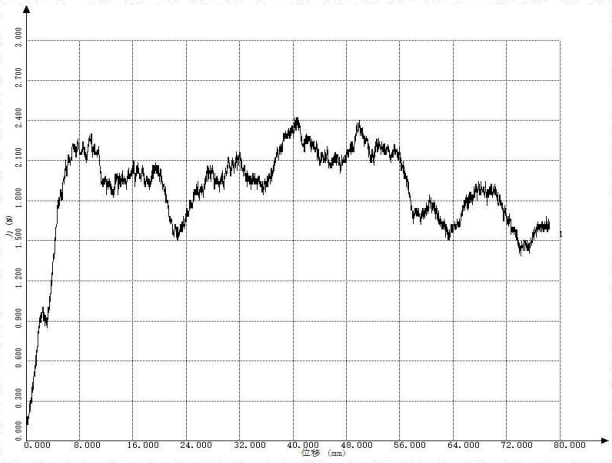
Fig.2-4 Test curve(23℃ 15min)

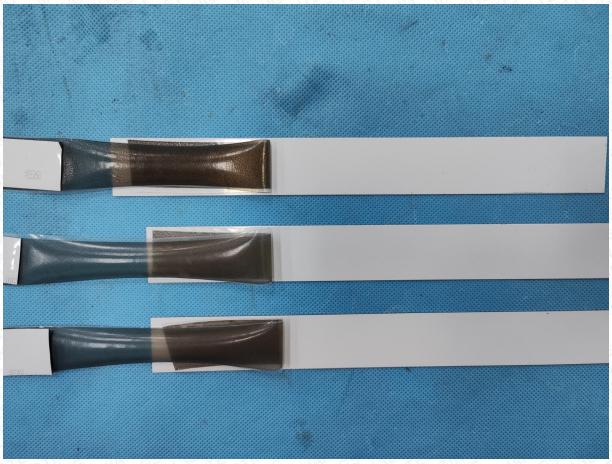
Fig.2-5 Sample photo after the test(23℃ 5min)

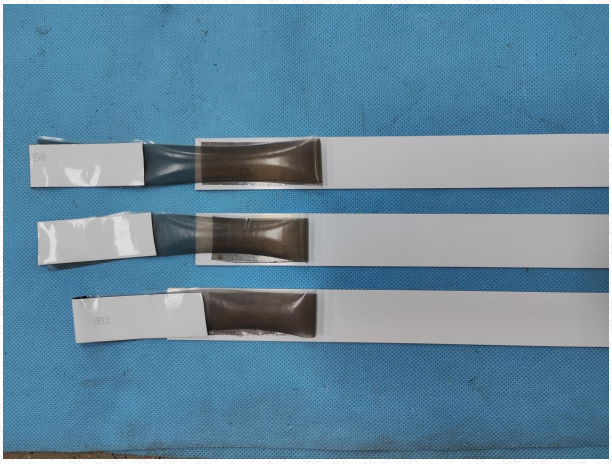
Fig.2-6 Sample photo after the test(23℃ 15min)
